# New York State Department of Transportation

## Yellow Flag NB2228W002

BIN: 1065318

Location: Span 30 Girder G1 at Pier 30

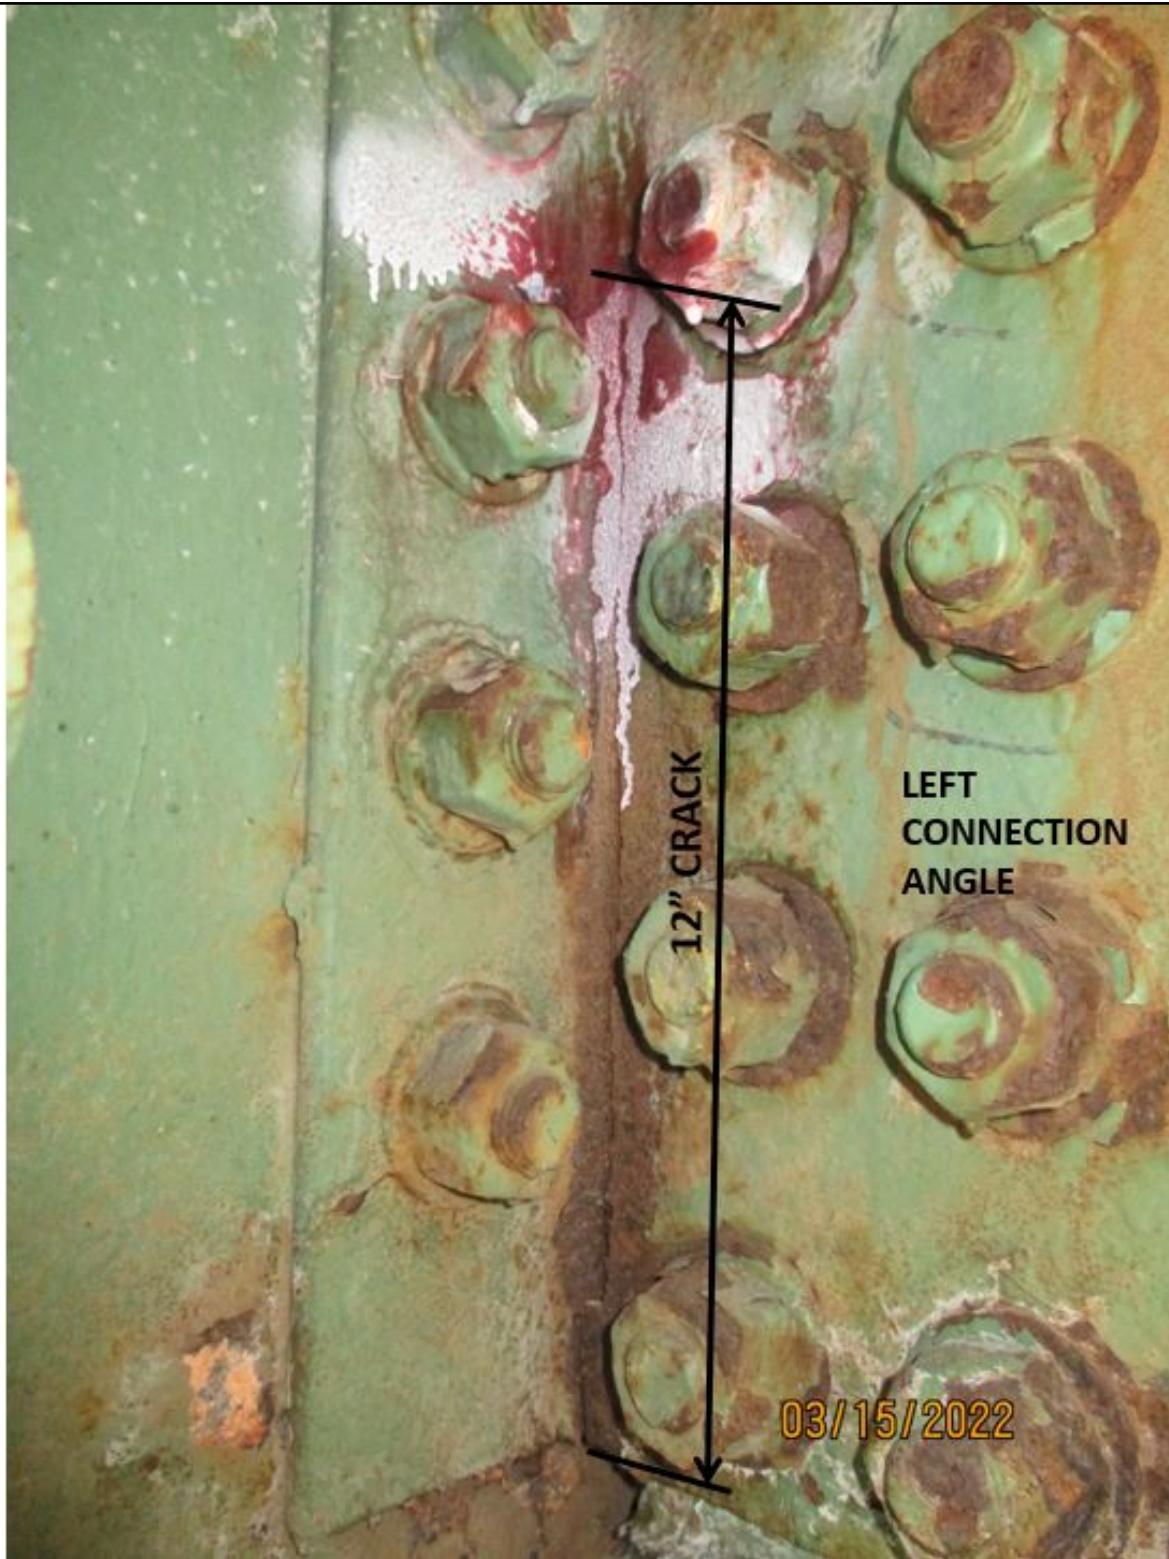
Photo Number: 3

Description: The left connection angle at Girder G1 connection to the Pier 30, left Column C1 exhibits a 12" long x 3/16" wide vertical crack at the lower fillet section, beginning at the base of the angle. This crack represents a loss of approximately 41% of the angle's total height of 29". There was no change from the previous inspection at this location. The right connection angle between Girder G1 and of Pier 30 (left Column C1) exhibits a 8-3/8" long x 1/8" wide vertical crack beginning 1/2" from the base of the angle. This crack has increased in length by 1-1/8" from 7-1/4" to 8-3/8" since the previous inspection. This crack represents a loss of approximately 29% of the angle's total height of 29".

**Attachment Description:** Span 30 Girder G1 at Pier 30 Column C1. Close-up view of left connection angle crack after dye-penetrant test at upper end of crack. Looking end and right.
